PARKING GARAGES

10 E. Ontario

Parking Garage Restoration & Post-Tension Cable Repair

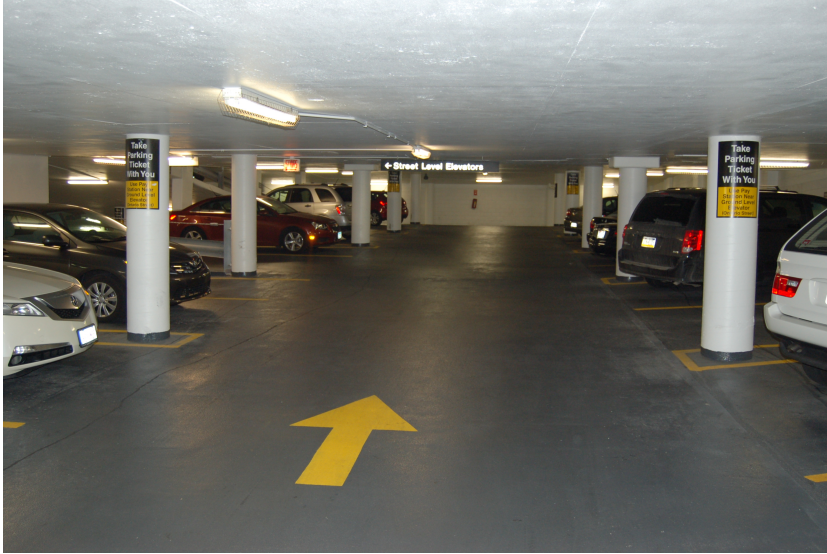
Exposure to weather over the past 30 years caused the exterior slab edge of the parking garage to become badly delaminated, causing exposure of the post-tension cables. Additionally, the connection points with the exterior metal panels had become compromised, causing concern about their stability. All work had to be conducted in phases with minimal impact to residents and the public—parking revenue could not be lost.

- Scaffolded the entire building and removed all exterior metal panels, giving access to the work without taking up additional parking
- Identified and performed all slab edge concrete repairs
- Installed BASF Conipur II traffic-bearing membrane
- Performed over 250 post-tension cable repairs
- Conducted 12 complicated phases to handle traffic re-routing and parking relocation with close contact with building management
- Repainted the entire garage and added new drains
- Cleaned, patched and repaired all metal panels
