## PLAZAS, PARKING GARAGES

# 1500 Sheridan Road

Plaza and Front Entry Renovation,  
Parking Lot Reconfiguration

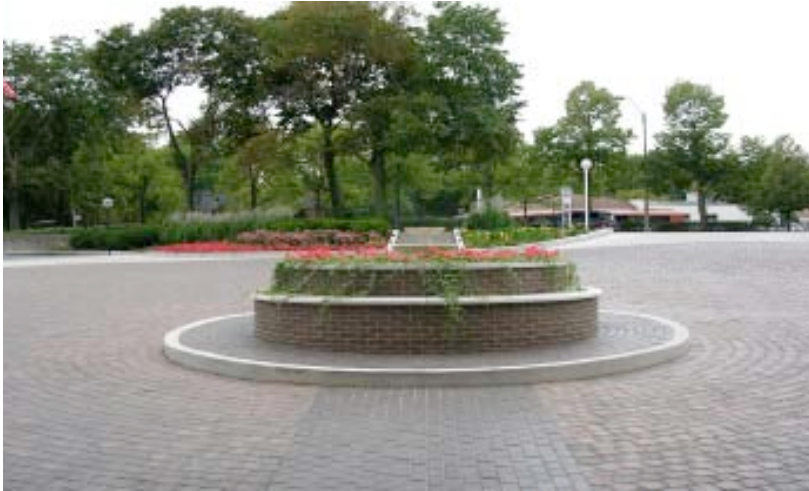
This high-rise condominium experienced water leakage into the parking garage underneath the center drive, requiring an architectural and structural overhaul. All work needed to be completed without closing the garage entry. There was also a need to accommodate installation of a hydraulic lift used to remove garbage from the lower level of the north parking lot and to make minor repairs in the south parking lot.

- Removed topping and membrane
- Repaired structural slab and replaced membrane and topping
- Installed hydronic snowmelt system with glycol
- Constructed new structural steel and EIFS entry canopy
- Fabricated and installed new aluminum hand rails
- Built new masonry ramp walls
- Center drive and building entrance remained open during construction
- Reconfigured north parking lot
